Residential Pre-purchase Inspection Report

Date of inspection: Monday, 16 June 2008 09:00 AM

Property address	17 Park Street RYDE NSW 2112
Report prepared for	Lisa Smith & Jack Smith Unit 3, 45 Fisher Way NETHERBY SA 5062
Client's contact details	Mobile 0555 231 357 roestbakken@ragnet.com.au
Real estate agent's details	Name Alexander Maxwell Company Maxwell & Company Mobile 0555 182 379
Type of inspection report	Standard Inspection, Defect Only
Persons present	Agent
Weather Conditions	Fine
Inspector	Inspector Gadget, Qualified Builder/Inspector General Builders Licence L1234567

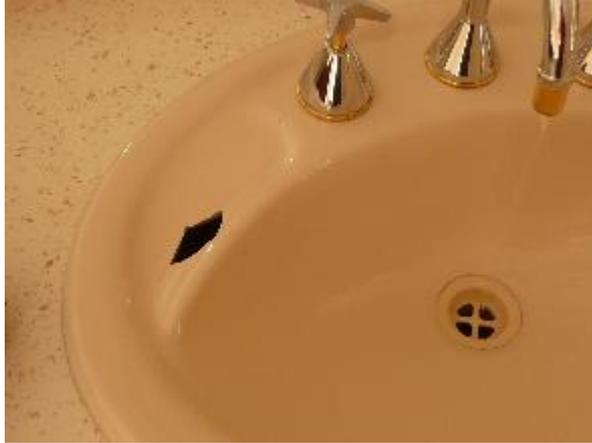
Wash basin

Cracks

Minor Defect

Interior > Bathroom > Wash basin > Cracks

Vanity holed - Recommend replacement by a plumber.

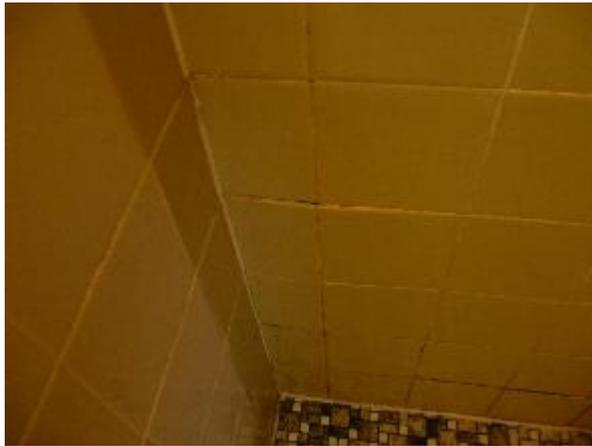
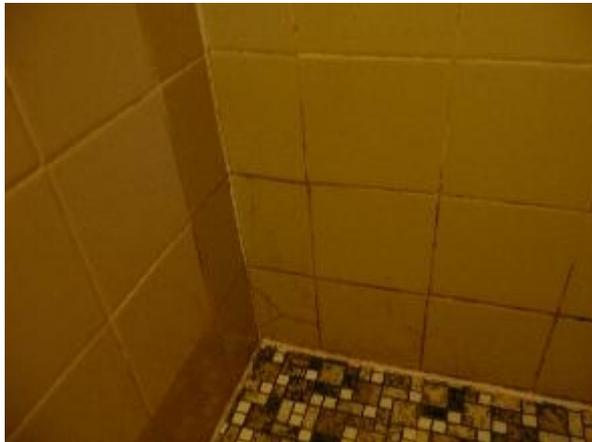
Shower tiles

Loose

Major Defect

Shower tiles popping, drummy & several sections of grout were gapped, holed or soft. High moisture meter readings to the shower tiles throughout the shower alcove. Recommend stripping the shower tiles, checking for and if necessary addressing leakage at shower taps, fittings or pipes, seal shower & re-tile. Tiler and plumber should be used.

Interior > Bathroom > Shower tiles > Loose

Shower tiles popping, drummy & several sections of grout were gapped, holed or soft. High moisture meter readings to the shower tiles throughout the shower alcove. Recommend stripping the shower tiles, checking for and if necessary addressing leakage at shower taps, fittings or pipes, seal shower & re-tile. Tiler and plumber should be used.

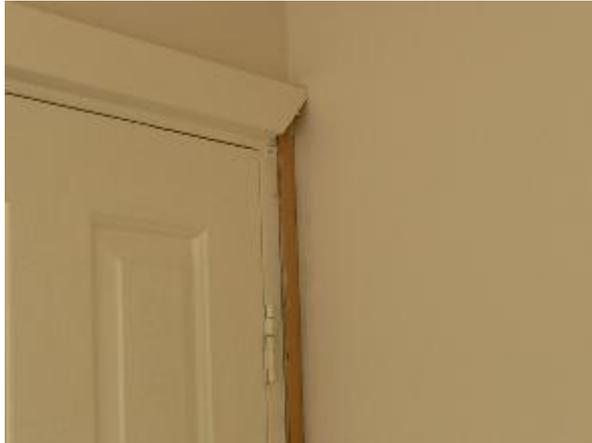
Doors and frames Architraves Minor Defect Type: F
Missing architrave on SW side of bathroom door.

Missing architrave on SW side of bathroom door.

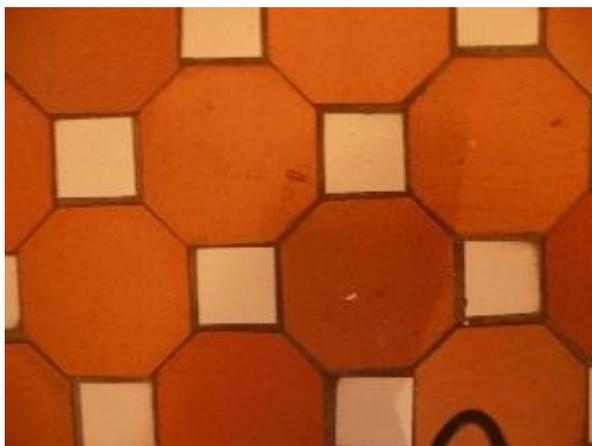
Floors Tiling loose Minor Defect Type: F
Poor quality DIY floor tiling. Recommend stripping tiles & re-tiling the floor.

Poor quality DIY floor tiling. Recommend stripping tiles & re-tiling the floor.

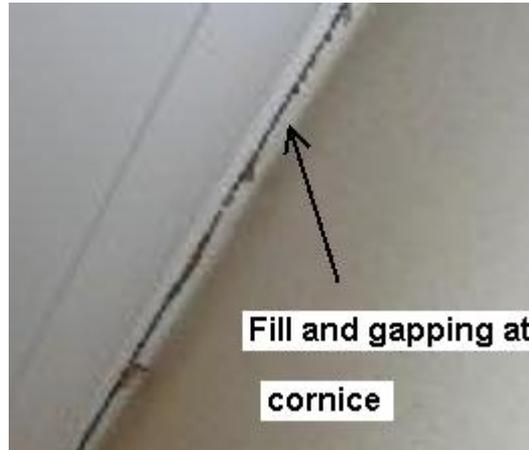
Ceilings & cornices Gapping at cornices Major Defect Type: B
Gapping at east cornice where repairs have been done in the past - consistent with lean-out in the east wall.

Gapping at east cornice where repairs have been done in the past - consistent with lean-out in the east wall.

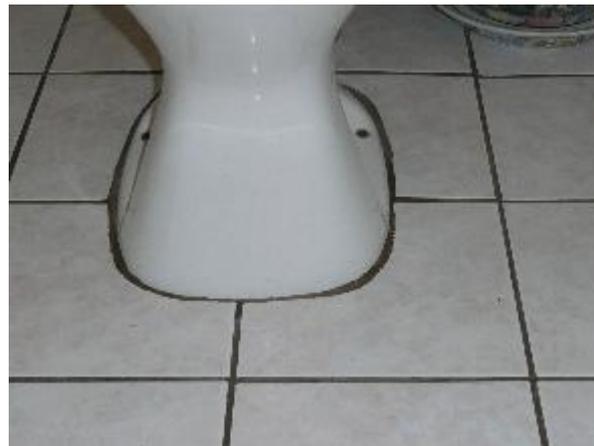
Floors Tiling Minor Defect Type: F
Tiling is over other tiles as seen at WC pan and at doorway to WC. May become loose over time.

Tiling is over other tiles as seen at WC pan and at doorway to WC. May become loose over time.

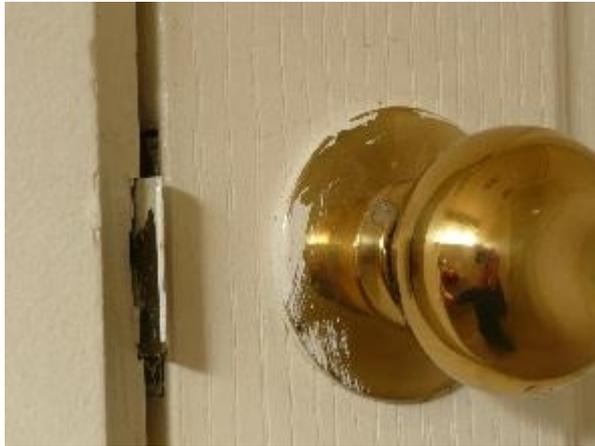
Painting Paintwork quality Minor Defect Type: F
Rough internal paintwork - paint over door furniture & not well cut in.

Rough internal paintwork - paint over door furniture & not well cut in.

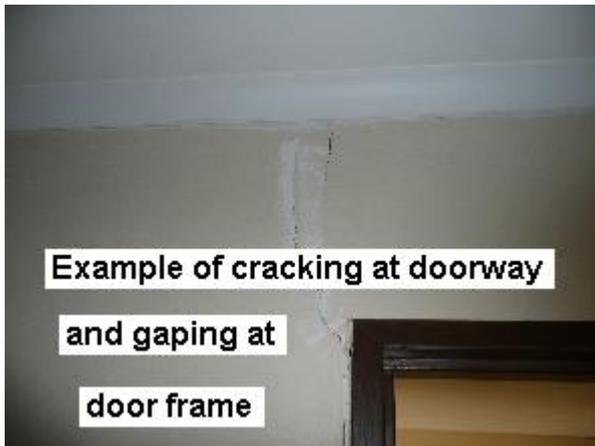
Walls Cracking Major Defect Type: A
Cracking repairs evident to door, corner & window areas in the kitchen/meals area. Likely to have been in excess of 15 mm in some areas given the rotation to the east in the east wall of the dine/lounge.

Cracking repairs evident to door, corner & window areas in the kitchen/meals area. Likely to have been in excess of 15 mm in some areas given the rotation to the east in the east wall of the dine/lounge.

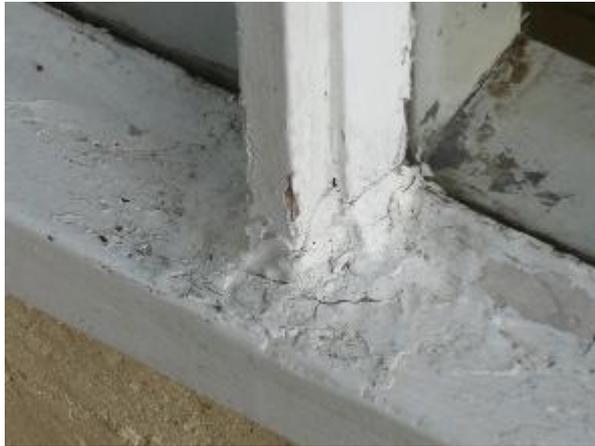
Windows Rot in timbers Minor Defect Type: D, C
Bogged rot in B1 window timbers. Replacement or better repair of the timbers warranted.

Bogged rot in B1 window timbers. Replacement or better repair of the timbers warranted.

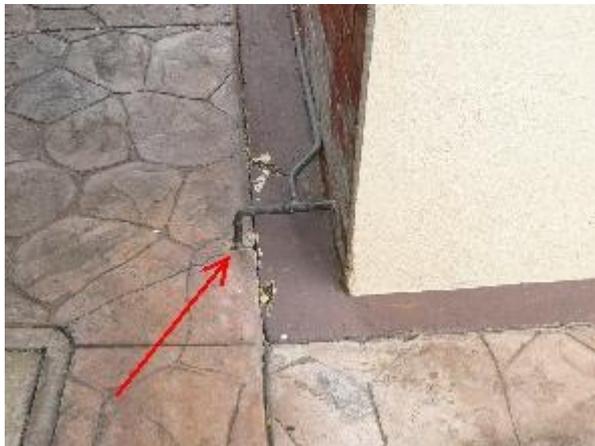
Perimeter paths Trip hazard Safety Hazard Type: F
Water piping by rear corner of toilet is a trip hazard.

Water piping by rear corner of toilet is a trip hazard.

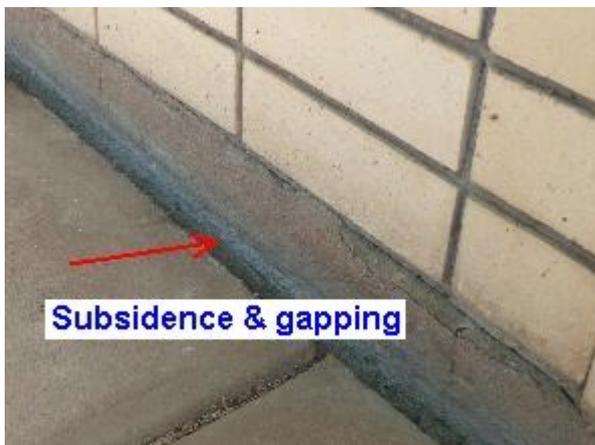
Perimeter paths Gapping between path & footing edge Minor Defect Type: B
Rear path has moved away from the footing edge & subsided.

Rear path has moved away from the footing edge & subsided.

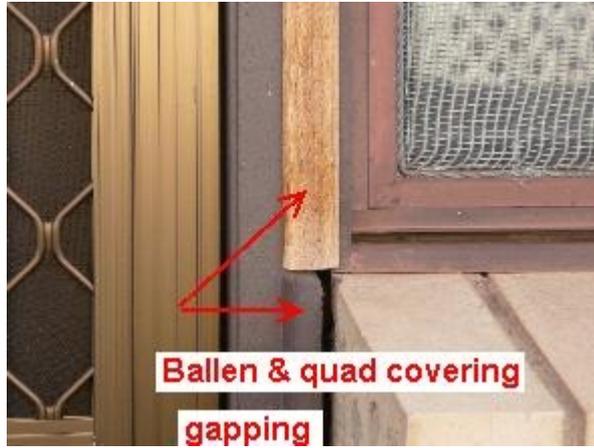
Walling Cracking - in excess of category 4 Major Defect Type: B
East side of the house has moved away from the remainder of the building as is evidenced by gapping at the back door which has been partly covered by a timber batten in recent times and prior to that by a quad strip.

East side of the house has moved away from the remainder of the building as is evidenced by gapping at the back door which has been partly covered by a timber batten in recent times and prior to that by a quad strip.

The east side of the house has subsided away with the subsidence being some 75mm at the front SE area & some 50mm to the rear NE area.

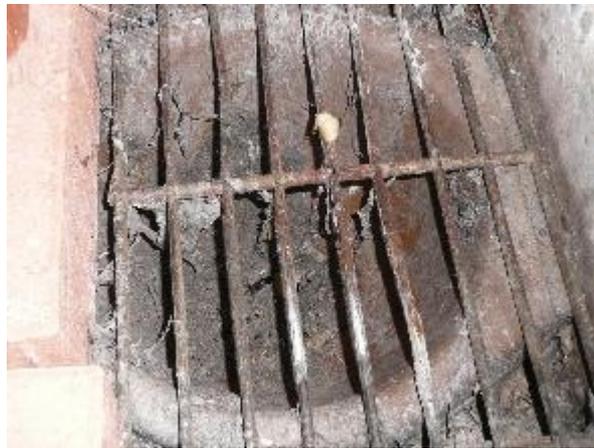
Gully sink Evidence of drain backing up at gully sink. Further Investigation Type: E
Remnants of sewerage at gully sink is evidence that the pipes have backed up. Recommend further investigation by a plumber.

Remnants of sewerage at gully sink is evidence that the pipes have backed up. Recommend further investigation by a plumber.

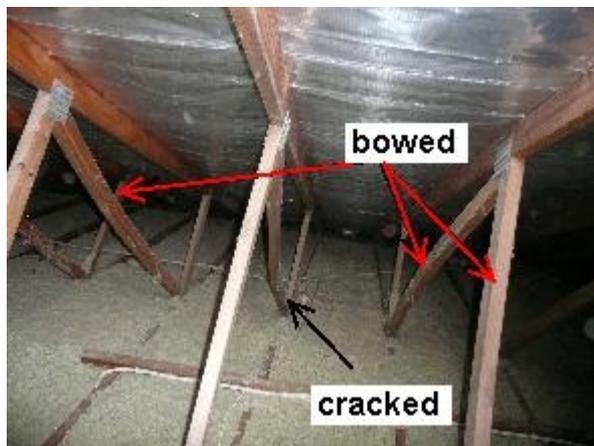
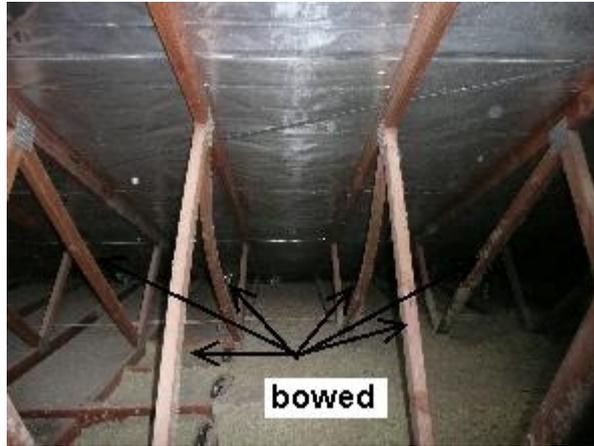
Roof framing Roof trusses show twist & excessive deflection Major Defect Type: B
Truss joint failure has lead to trusses distorting & twisting and to cracking of some truss webs.

Truss joint failure has lead to trusses distorting & twisting and to cracking of some truss webs.

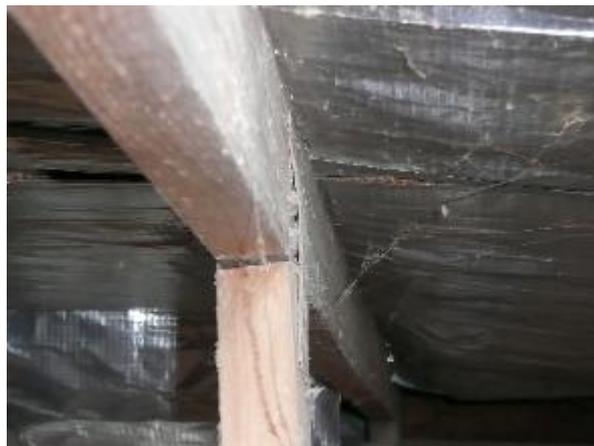
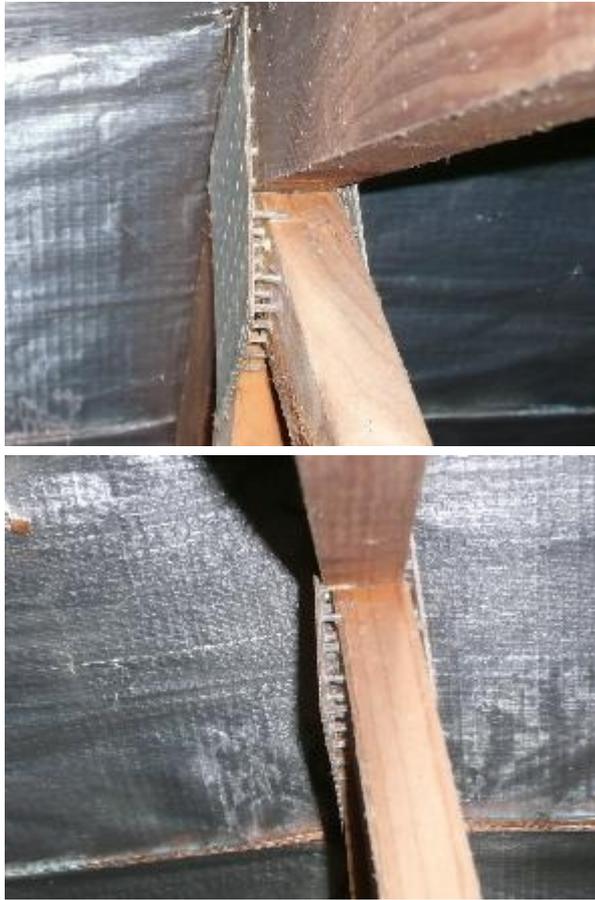
Roof framing

Roof trusses have gang nail plate separation

Major Defect

Gang nails in roof trusses have come part way out of the truss connections. This is a major structural problem that results in severe weakening of the truss joints & the trusses. It can lead to truss failure. Applies to approximately 150 truss gang nail plates in this roof.

This self-extraction is known as the “mechano-sorptive effect”. This truss problem is the subject of SA Government Building Advisory notices 18/06, 17/06 and 28/04 which can be found on the Planning SA web site.

In this instance, the extent of self extraction of the gang nail plates is severe, being over 5 mm in some instances and having resulted in bowed trusses, bowed truss webs & truss cords and trust sag.

In a severe storm, there is a risk of truss failure & roof collapse.

The roof trusses have gang nail plate separation making the trusses liable to structural failure.

To remedy the problem would involve replacing the roof framing. That involves removal of the flashings, roof tiles, the roof wiring, in-roof gravity feed HWS & associated plumbing, roof sarking & blown-in insulation, ceilings, gutters, barges & fascias, valleys then the truss connections & finally the trusses. Then rebuild. This extent of work would also require appropriate design, documentation & Council approval.
