Residential Pre-purchase Inspection Report

Date of inspection: Monday, 16 June 2008 09:00 AM

Property address	17 Park Street RYDE NSW 2112
Report prepared for	Lisa Smith & Jack Smith Unit 3, 45 Fisher Way NETHERBY SA 5062
Client's contact details	Mobile 0555 231 357 roestbakken@ragnet.com.au
Real estate agent's details	Name Alexander Maxwell Company Maxwell & Company Mobile 0555 182 379
Type of inspection report	Standard Inspection, Defect Only
Persons present	Agent
Weather Conditions	Fine
Inspector	Inspector Gadget, Qualified Builder/Inspector General Builders Licence L1234567

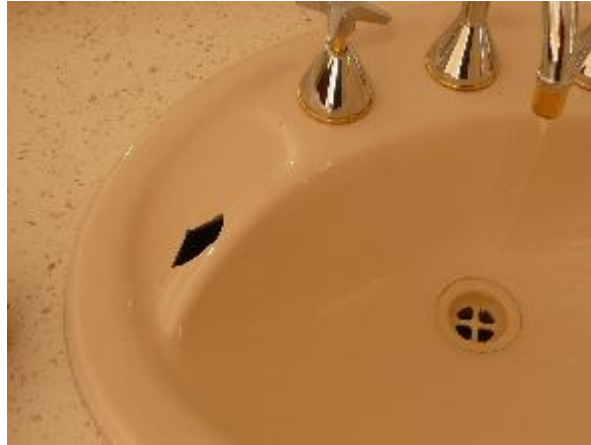
Wash basin

Cracks

Minor Defect

Type: A

Vanity holed - Recommend replacement by a plumber.

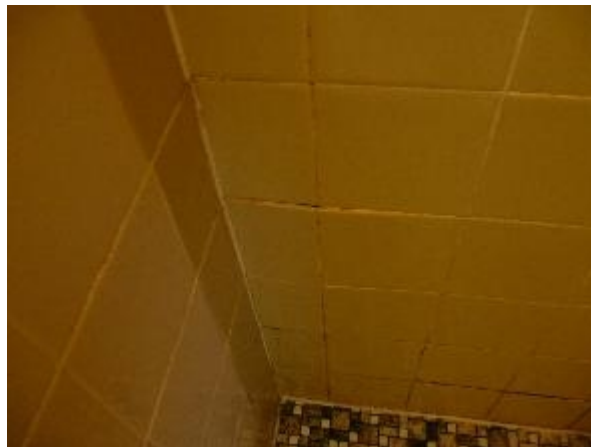
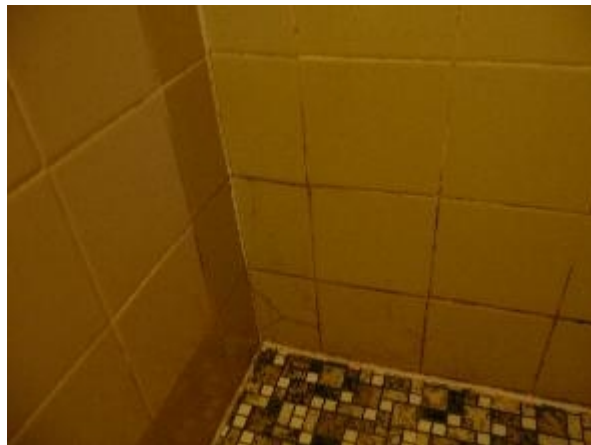
Shower tiles

Loose

Major Defect

Type: E, C, A,
B

Shower tiles popping, drummy & several sections of grout were gapped, holed or soft. High moisture meter readings to the shower tiles throughout the shower alcove. Recommend stripping the shower tiles, checking for and if necessary addressing leakage at shower taps, fittings or pipes, seal shower & re-tile. Tiler and plumber should be used.

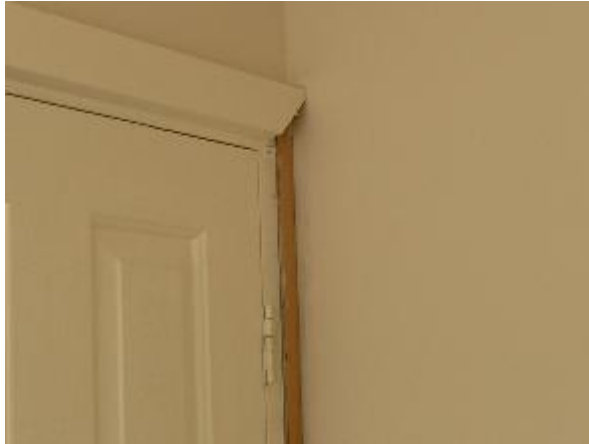
Doors and frames Architraves Minor Defect Type: F
Missing architrave on SW side of bathroom door.

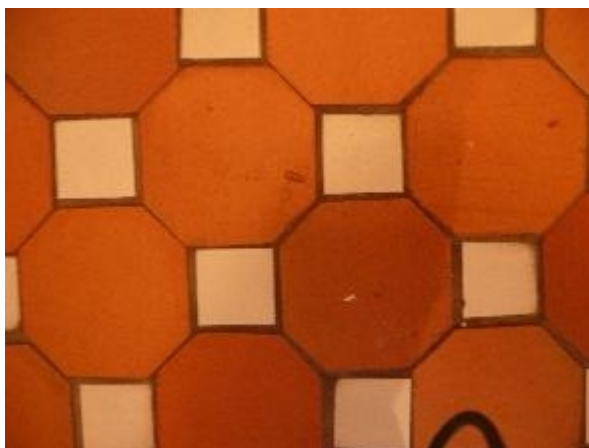
Floors Tiling loose Minor Defect Type: F
Poor quality DIY floor tiling. Recommend stripping tiles & re-tiling the floor.

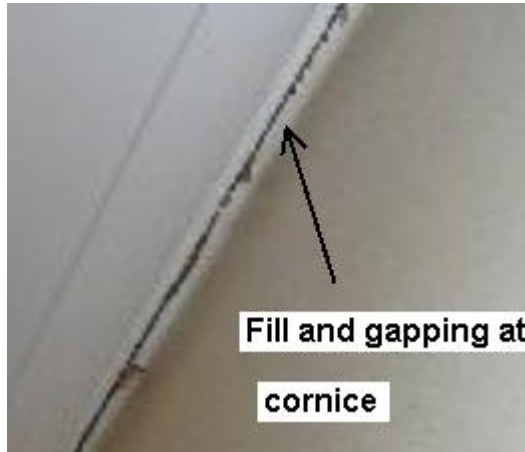
Ceilings & cornices Gapping at cornices Major Defect Type: B
Gapping at east cornice where repairs have been done in the past - consistent with lean-out in the east wall.

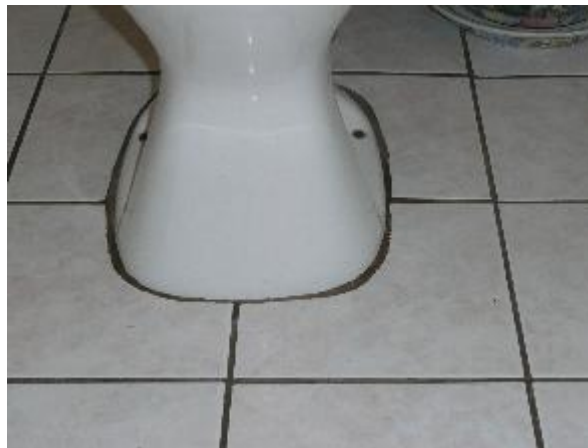
Floors Tiling Minor Defect Type: F
Tiling is over other tiles as seen at WC pan and at doorway to WC. May become loose over time.

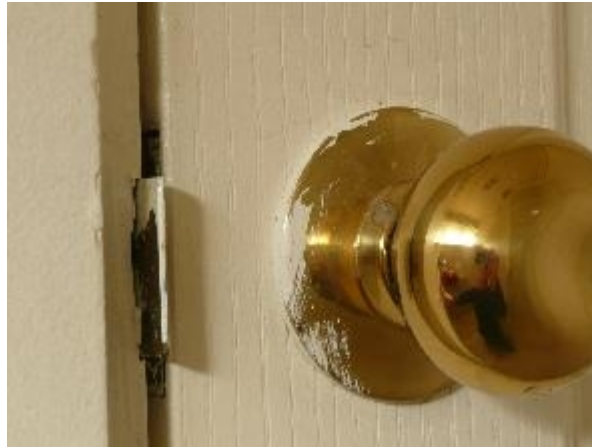
Painting Paintwork quality Minor Defect Type: F
Rough internal paintwork - paint over door furniture & not well cut in.

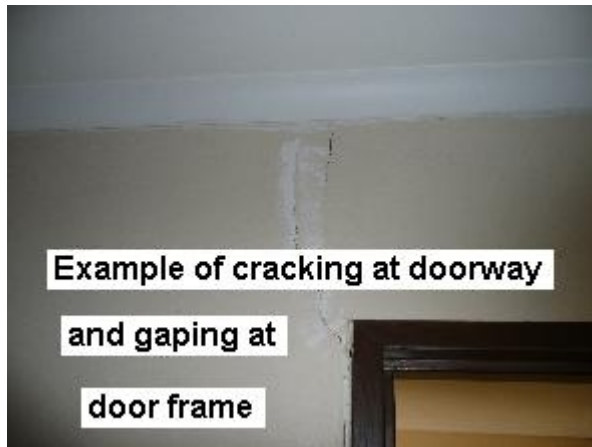
Walls Cracking Major Defect Type: A
Cracking repairs evident to door, corner & window areas in the kitchen/meals area. Likely to have been in excess of 15 mm in some areas given the rotation to the east in the east wall of the dine/lounge.

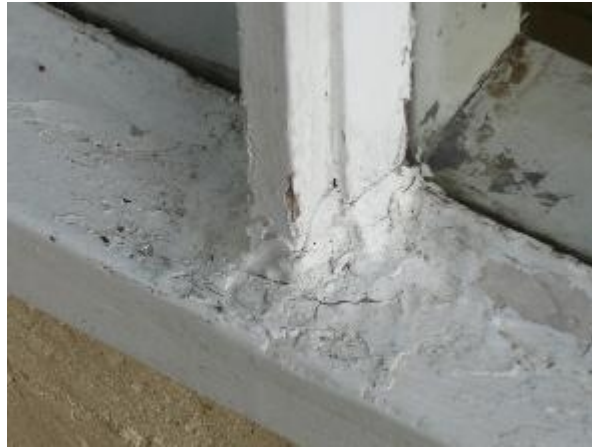
Windows Rot in timbers Minor Defect Type: D, C
Bogged rot in B1 window timbers. Replacement or better repair of the timbers warranted.

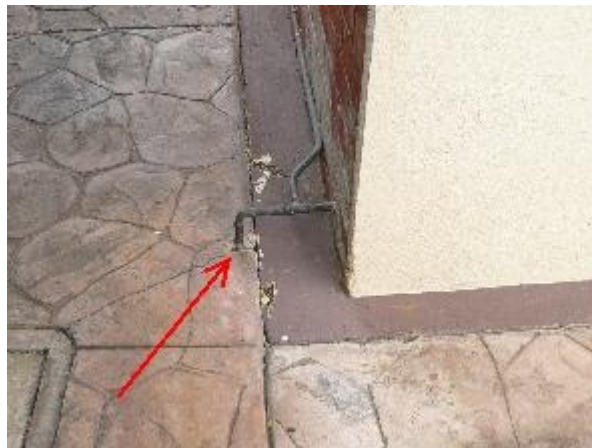
Perimeter paths Trip hazard Safety Hazard Type: F
Water piping by rear corner of toilet is a trip hazard.

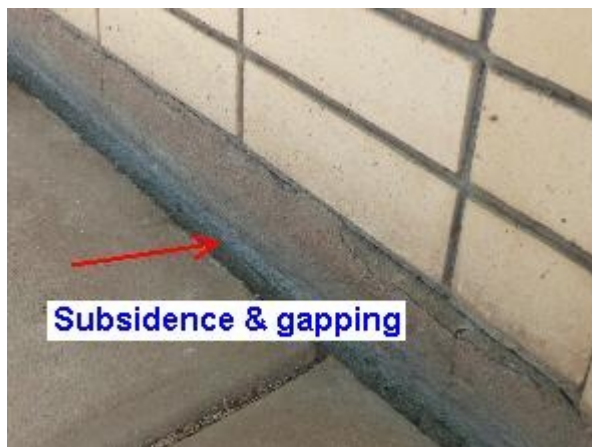
Perimeter paths Gapping between path & footing edge Minor Defect Type: B
Rear path has moved away from the footing edge & subsided.

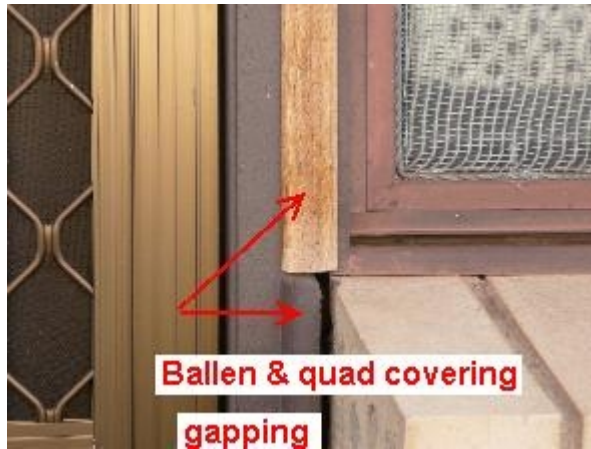
Walling Cracking - in excess of category 4 Major Defect Type: B
East side of the house has moved away from the remainder of the building as is evidenced by gapping at the back door which has been partly covered by a timber batten in recent times and prior to that by a quad strip.

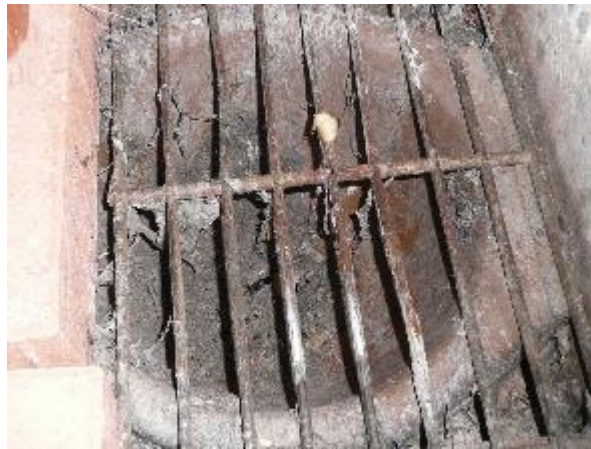
Gully sink Evidence of drain backing up at gully sink. Further Investigation Type: E
Remnants of sewerage at gully sink is evidence that the pipes have backed up. Recommend further investigation by a plumber.

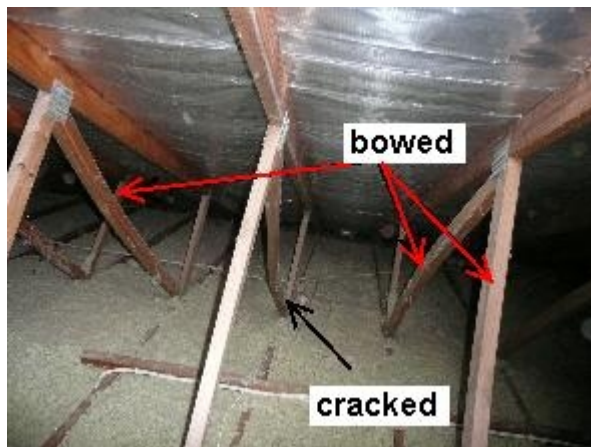
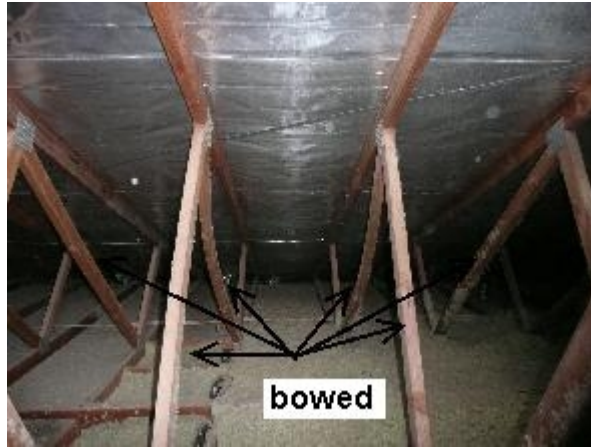
Roof framing Roof trusses show twist & excessive deflection Major Defect Type: B
Truss joint failure has lead to trusses distorting & twisting and to cracking of some truss webs.

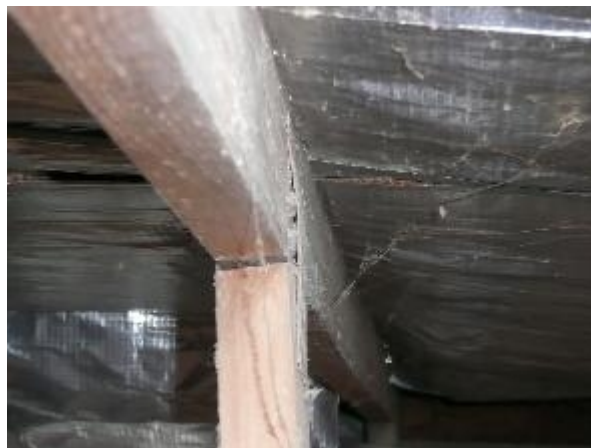
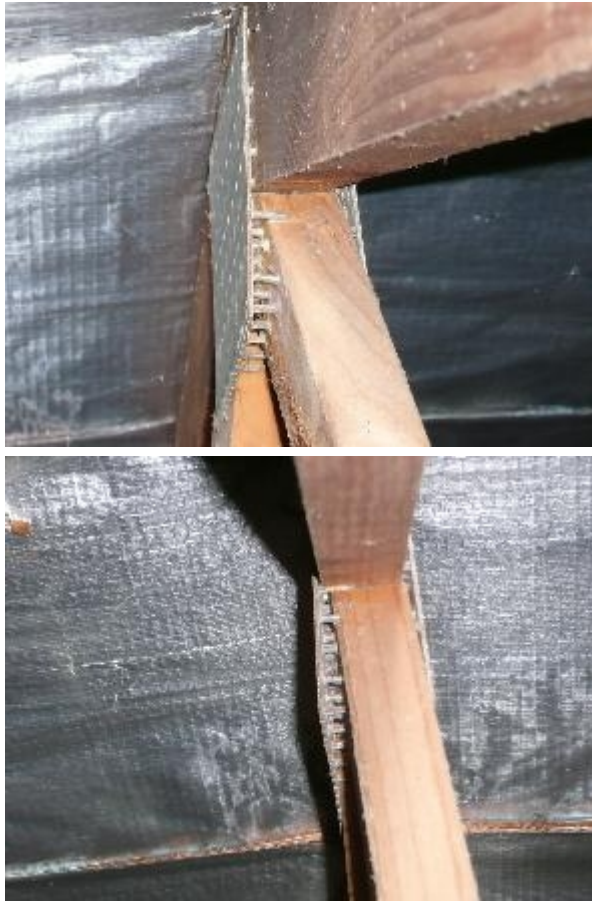
Roof framing

Roof trusses have gang nail plate separation

Major Defect

Type: B

Gang nails in roof trusses have come part way out of the truss connections. This is a major structural problem that results in severe weakening of the truss joints & the trusses. It can lead to truss failure. Applies to approximately 150 truss gang nail plates in this roof.

This self-extraction is known as the “mechano-sorptive effect”. This truss problem is the subject of SA Government Building Advisory notices 18/06, 17/06 and 28/04 which can be found on the Planning SA web site.

In this instance, the extent of self extraction of the gang nail plates is severe, being over 5 mm in some instances and having resulted in bowed trusses, bowed truss webs & truss cords and trust sag.

In a severe storm, there is a risk of truss failure & roof collapse.

To remedy the problem would involve replacing the roof framing. That involves removal of the flashings, roof tiles, the roof wiring, in-roof gravity feed HWS & associated plumbing, roof sarking & blown-in insulation, ceilings, gutters, barges & fascias, valleys then the truss connections & finally the trusses. Then rebuild. This extent of work would also require appropriate design, documentation & Council approval.
