Residential Pre-purchase Inspection Report

Australian Standard AS 4349.1 - 2007 Pre-purchase Inspections - Residential buildings

32 Altoa Rd
MODELLA VIC 3816

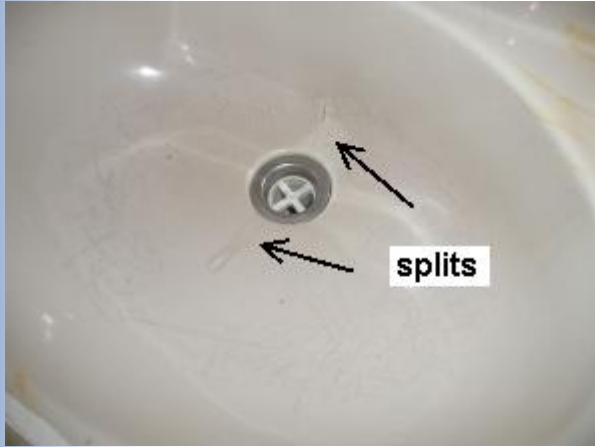
Cracks

Split in wash basin.

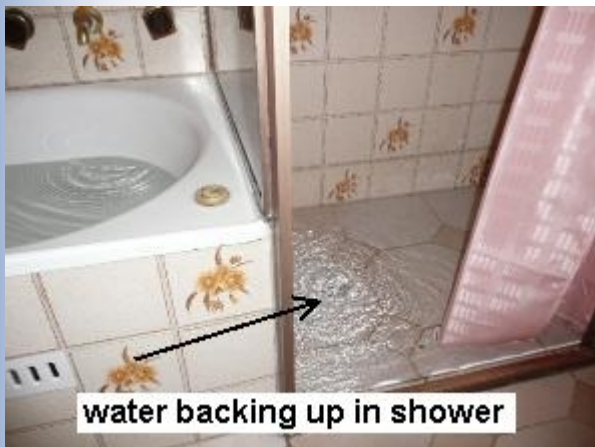
Bath discharge

Partial blockage indicated when bath was discharged. Water backed up into the shower floor.

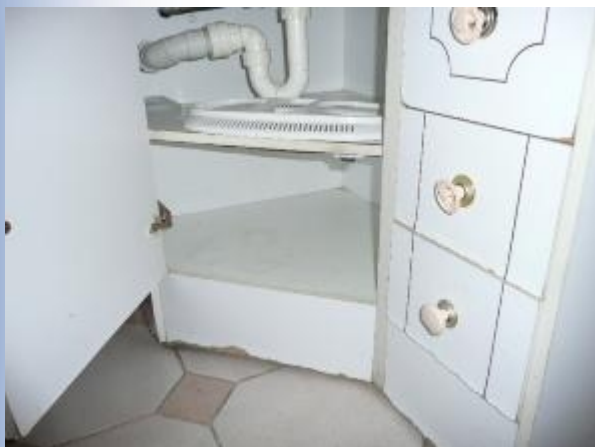
Water damage

General deterioration to vanity cabinet.

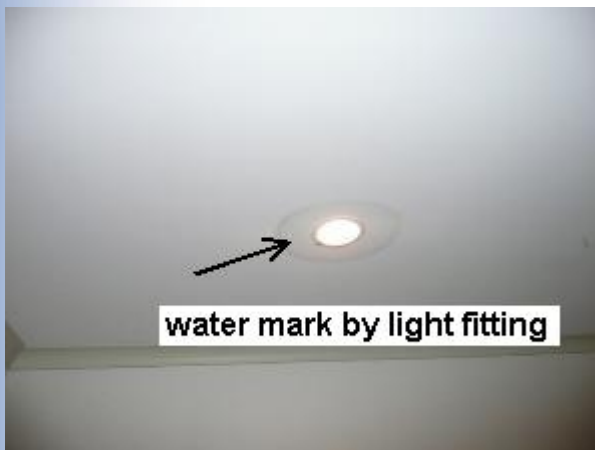
Ceilings & cornices	Dampness and damp damage	Major Defect	Type: D
---------------------	--------------------------	--------------	---------

Water mark at light fitting indicates leakage.

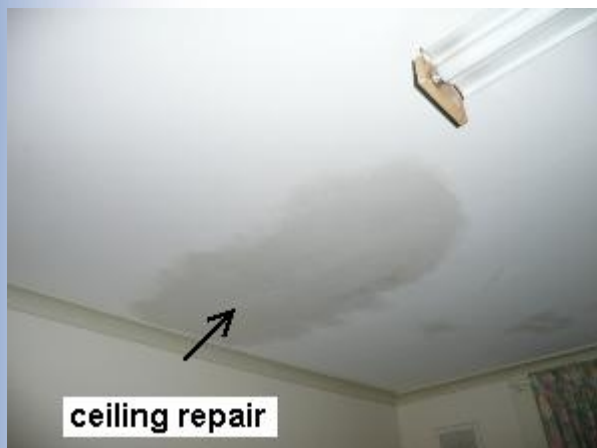
Ceilings & cornices Dampness and damp damage Major Defect Type: D
Leakage under the low pitched area of corrugated galvanised iron sheeting.

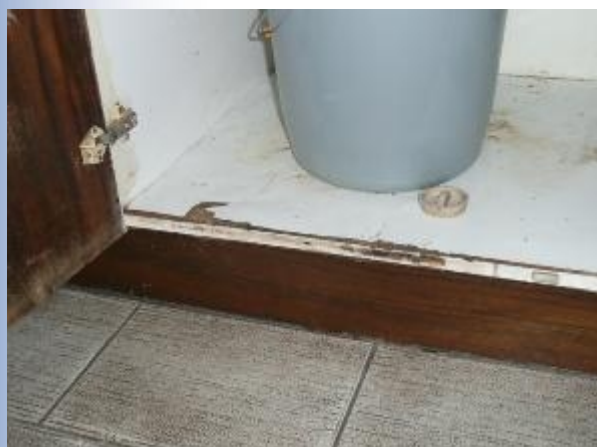
Cupboards Damaged carcass Minor Defect Type: A, D
General deterioration to kitchen cupboards

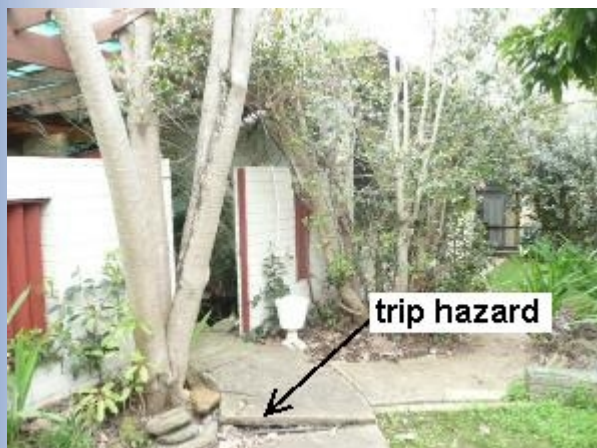
Perimeter paths Trip hazard Safety Hazard Type: F, A
Heaved & uneven path at front to remove & re-lay if required - presently constitutes a trip hazard.

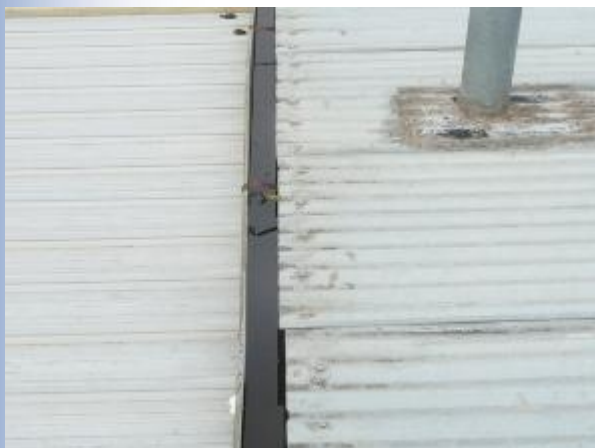
Guttering Insufficient gutter grade Major Defect Type: F
Rear gutter holding water - Recommend re-grading the gutter or install another down pipe.

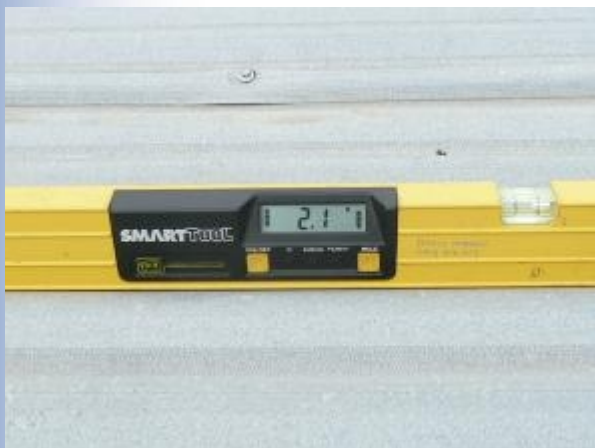
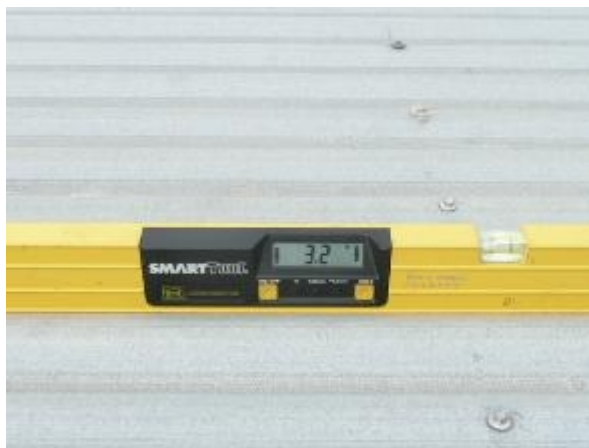
Roof iron Insufficient pitch for corrugated roof iron Major Defect Type: F
Corrugated iron roof sheet pitch measured at between 2.3° & 3.2°, well under the minimum of 5° allowed. Evidence of leakage repairs in kitchen & B3 ceilings. Ongoing areas of leakage are to be expected when corrugated iron is on too low a pitch. Some corrosion to laps of the roof iron.

Corrugated iron roof sheet pitch measured at between 2.3° & 3.2°, well under the minimum of 5° allowed. Evidence of leakage repairs in kitchen & B3 ceilings. Ongoing areas of leakage are to be expected when corrugated iron is on too low a pitch. Some corrosion to laps of the roof iron.

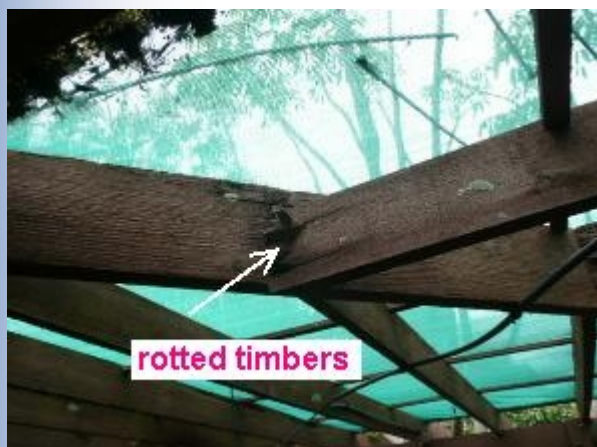
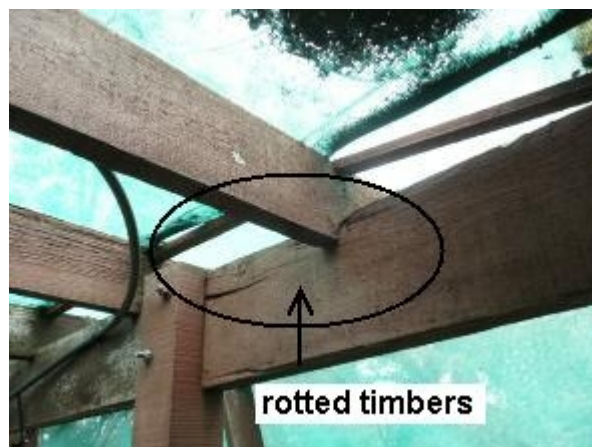
Pergola Shade cloth deteriorated Minor Defect Type: D
Shade cloth in poor condition & would warrant replacing if the pergola were to be restored.

Pergola Translucent sheeting brittle & UV damaged Minor Defect Type: D
Translucent sheeting to pergola in poor condition and warrants replacement.

Pergola Rot to timbers Minor Defect Type: D
General deterioration in pergola timbers due to lack of timely maintenance.

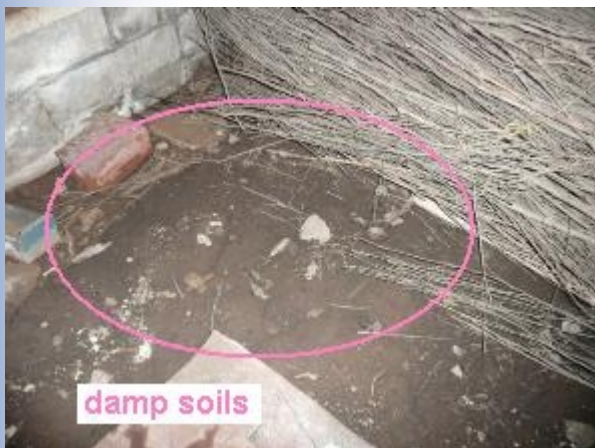
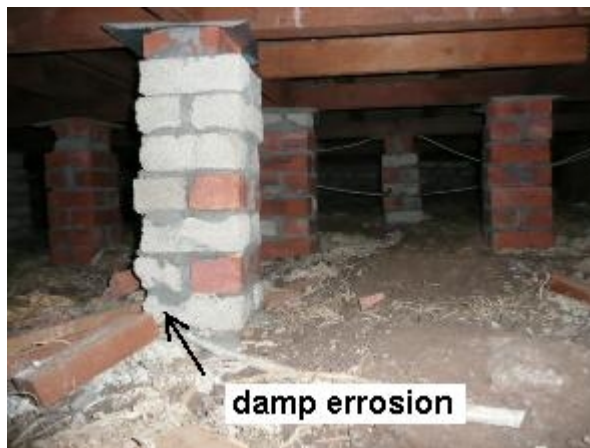
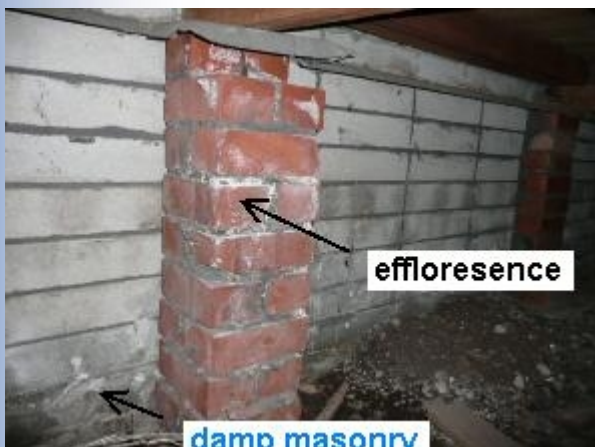
Moisture Moist ground under floor Major Defect Type: D

Moist grounds under floor are evidence of lack of run off & roof water discharging to ground near the building.

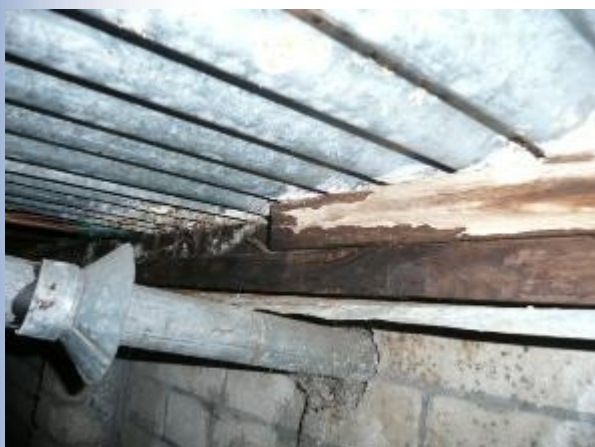
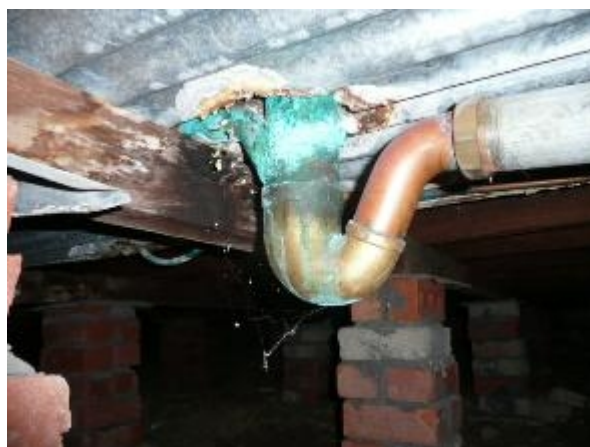
Moisture Evidence of leakage under floor Major Defect Type: D

Leakage evidence seen under the shower area at edge under taps (rot to framing evident) and also by bath waste. Recommend a plumber repair all leakages.

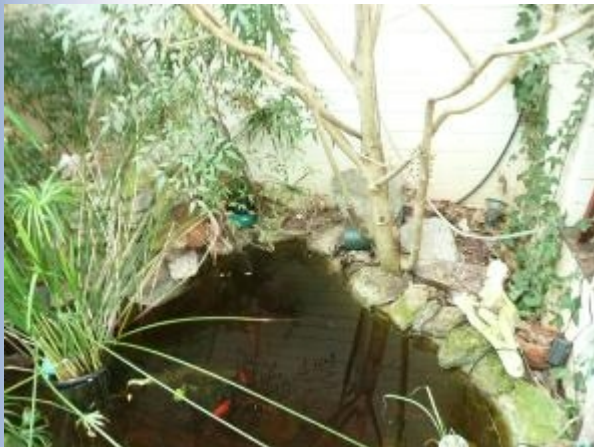
Leakage Fish pond by wall leaking Major Defect Type: F, D
Recommend removing the fish pond. Leakage can add to movement, localised damp & increase termite risk. The pond can also be a safety hazard for young children.
